CIVIL AERONAUTICS BOARD

ACCIDENT INVESTIGATION REPORT

UNITED AIR LINES, INC., DOUGLAS C-54B-DC, N 30062
MEDICINE BOW PEAK, WYOMING, OCTOBER 6, 1955

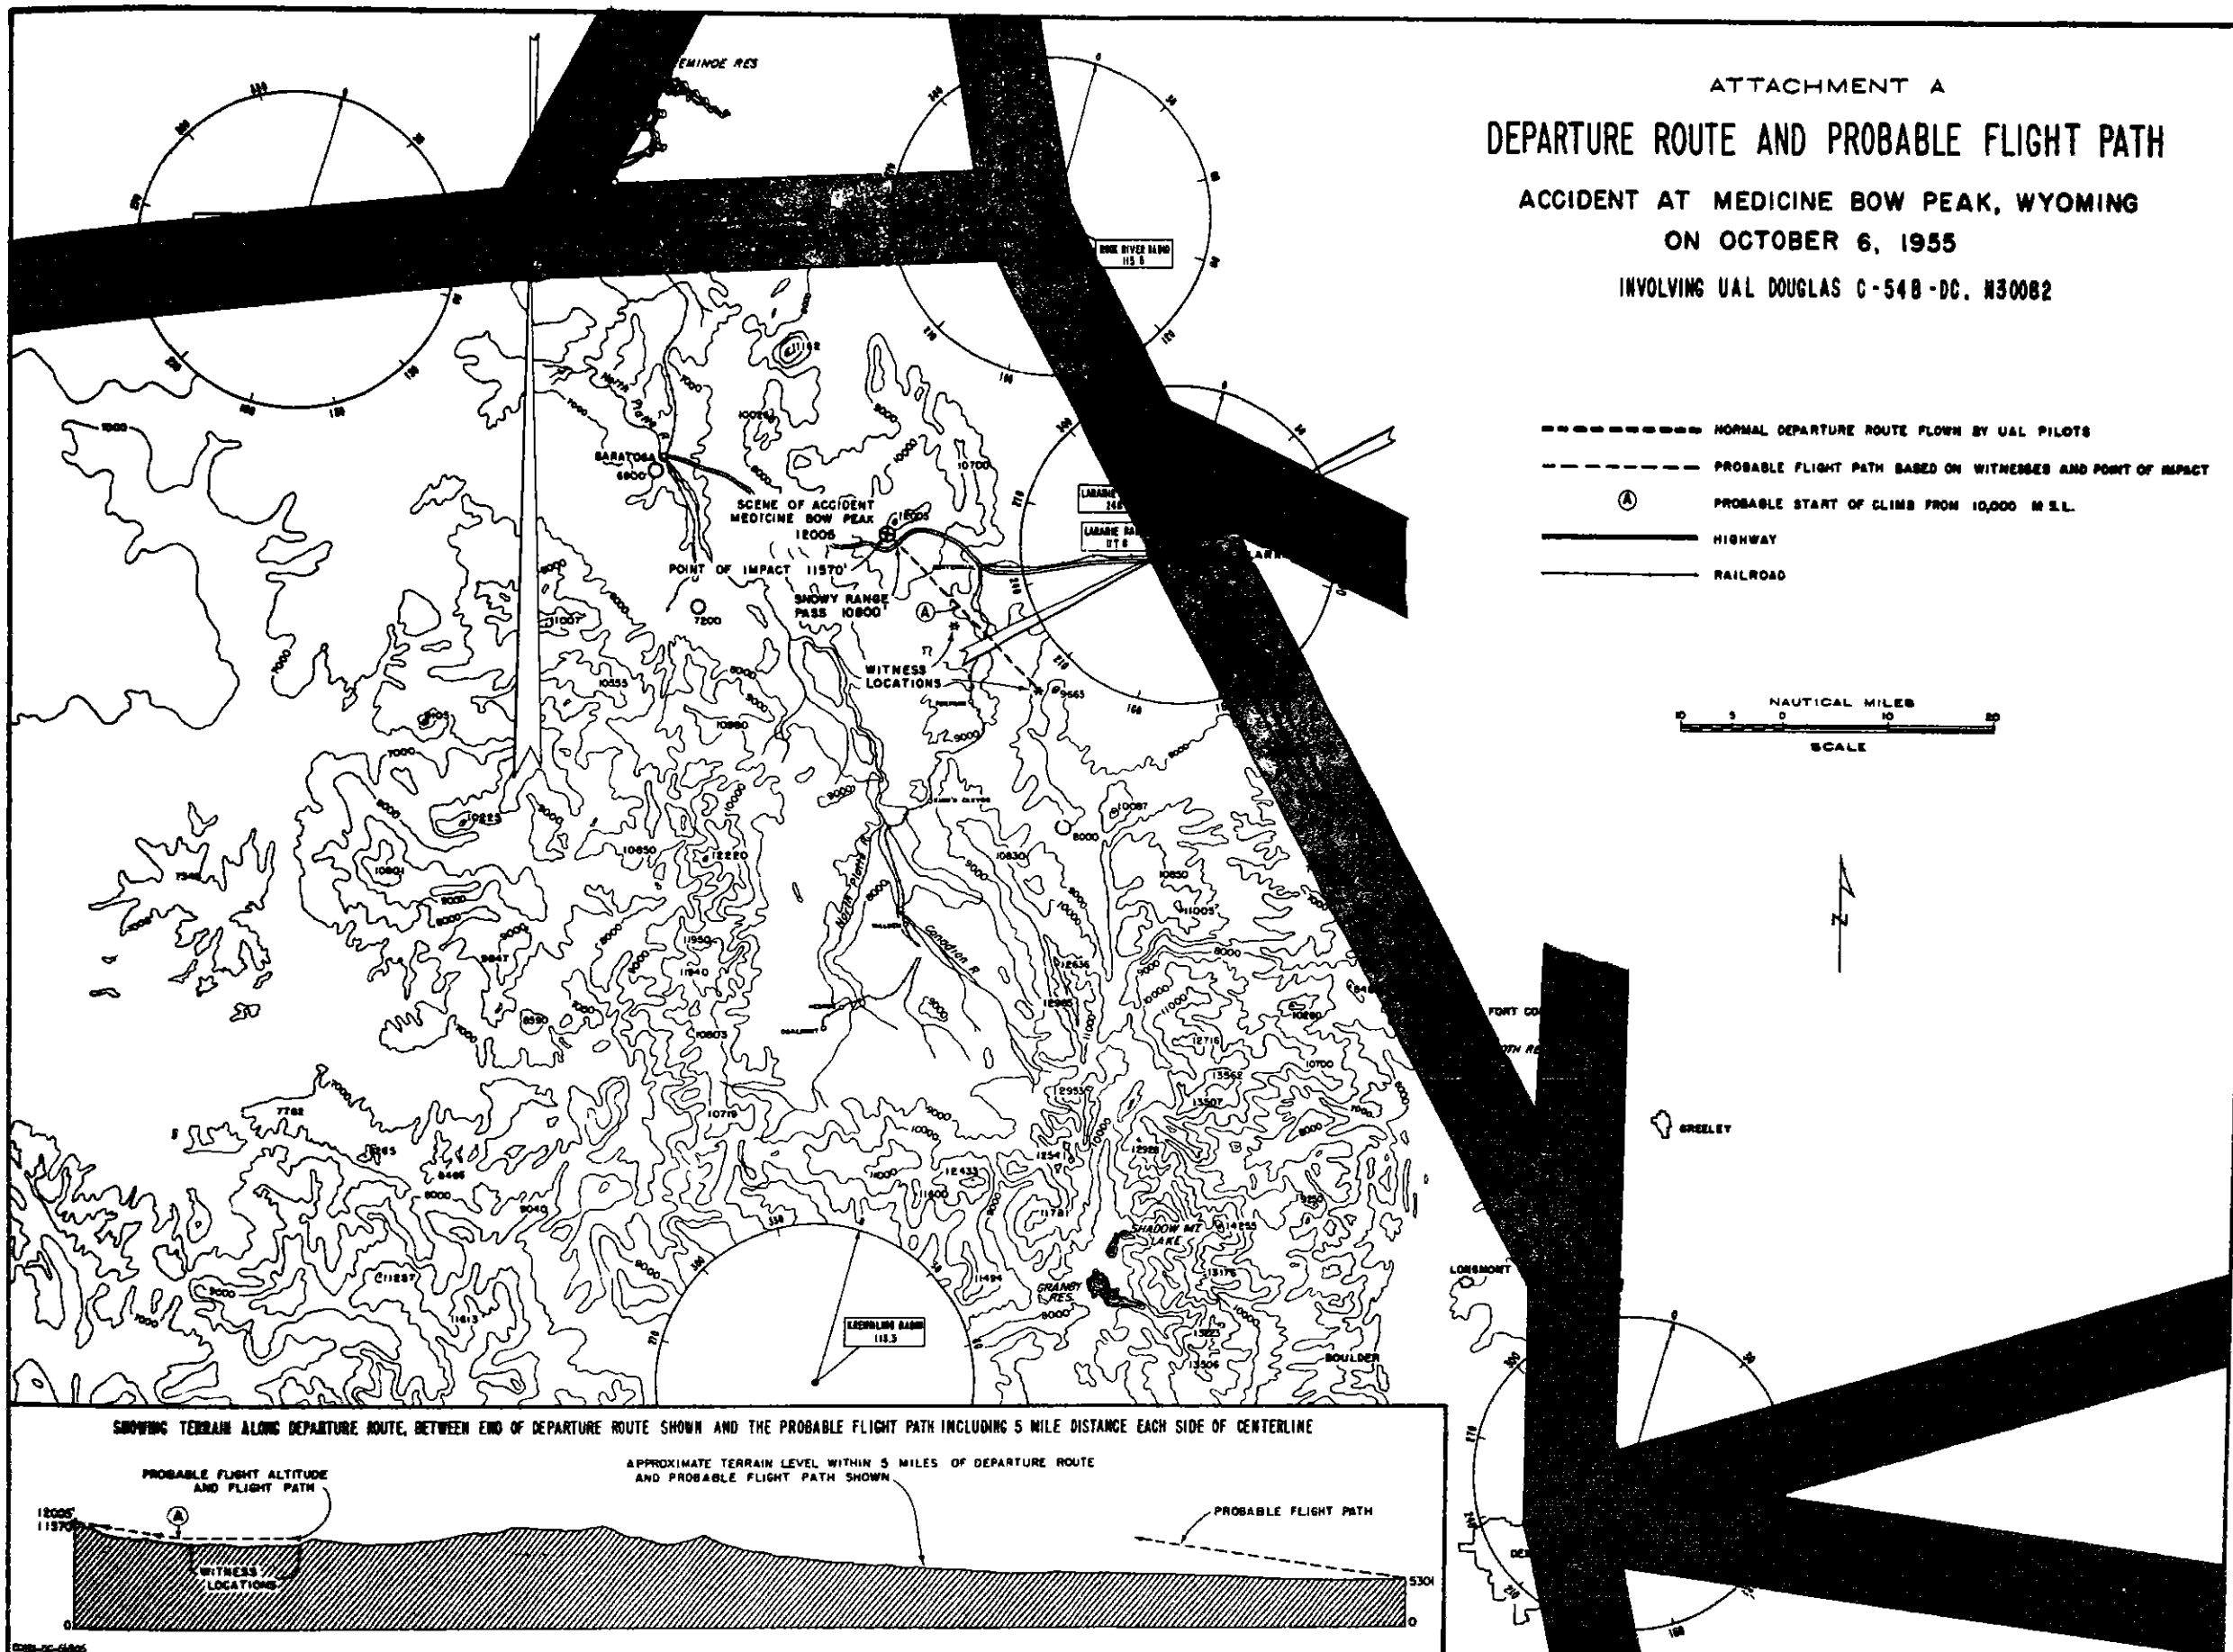
ATTACHMENT A
 DEPARTURE ROUTE AND PROBABLE FLIGHT PATH
 ACCIDENT AT MEDICINE BOW PEAK, WYOMING
 ON OCTOBER 6, 1955
 INVOLVING UAL DOUGLAS C-54B-DC. N30082

As a result of information obtained from the witnesses, a probable flight path was constructed. (See Attachment A.) This flight path, projected from the accident site on a magnetic heading of 120 degrees, covered a distance of approximately 23 miles. An extension of this flight path to the southeast crosses the planned route in the vicinity of Ft. Collins, Colorado, and to the northwest again crosses it near Rawlins, Wyoming.
